Skaneateles Lake Watershed Composting Toilet Project

Rich Abbott

Abstract:

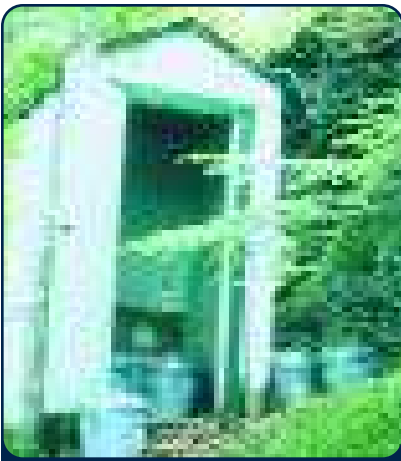
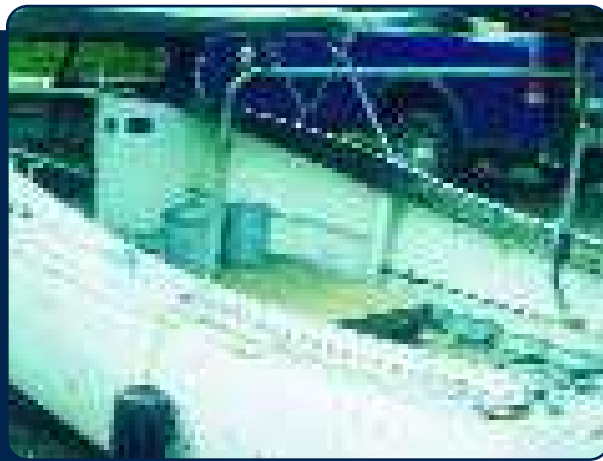
Prior to the composting toilet project, many lakeside residents in Skaneateles relied on a pail pick-up service initiated in 1908 to dispose of their household sewage. Five-gallon pails of raw sewage were transported by truck and boat to Syracuse. Photos by Rich Abbott.

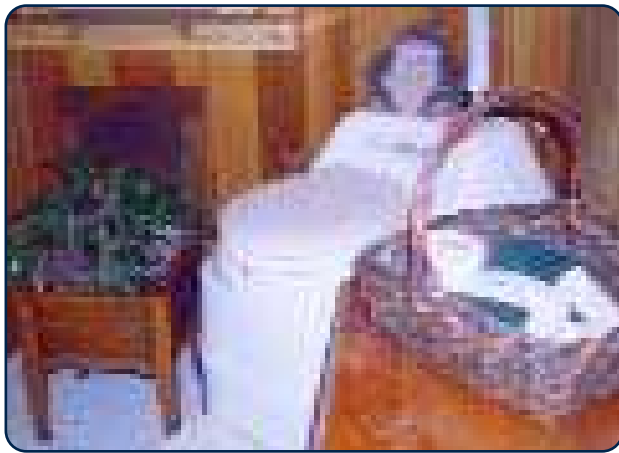
Above: Composting toilet inside a Skaneateles residence. Below: Privy outside the same home retrofitted with a composting toilet. Photos by Rich Abbott.

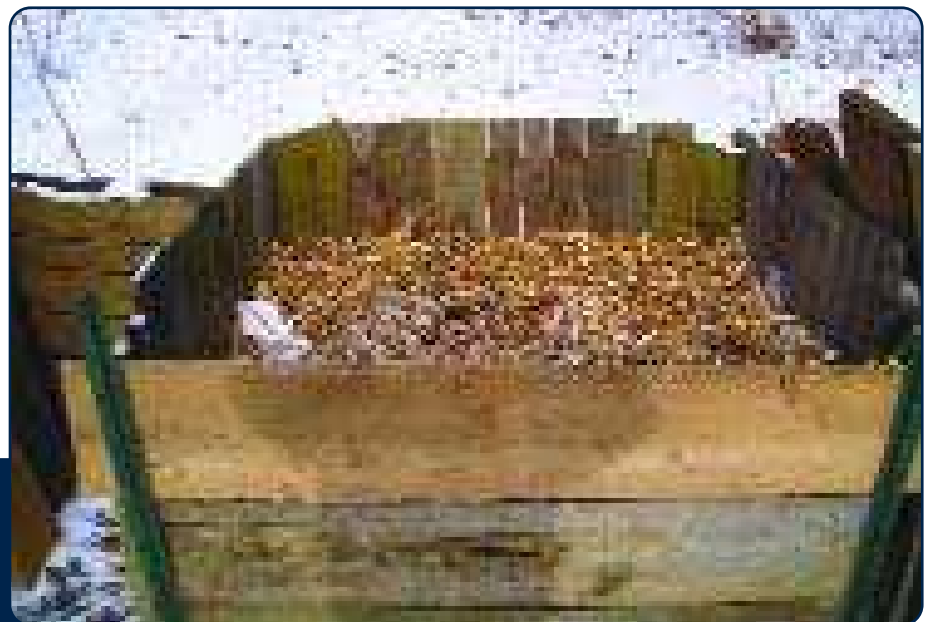
Bin holding finished toilet compost. The compost is combined with fresh grass clippings, hay, and mulch and is allowed to secondary compost. Alternate bins allow compost to age for a minimum of two years. Photos by Rich Abbott.

In an effort to further reduce or eliminated pathogens and satisfy NYSDOH conditions regarding collection and disposal of finished compost, the city has elected to collect this material from compost sites on a designated date each spring. City personnel transfer five-gallon pails of finished compost to 4-ft square composting bins on city property within the watershed. The finished compost is combined with fresh grass clippings, hay and mulch and allowed to secondary compost. The City is experimenting with establishing optimal carbon:nitrogen (C:N) ratios, moisture, and aerobic conditions within the piles in an effort to achieve thermophilic conditions (over 105°F). Alternate bins have been constructed allowing the compost to age for a minimum of two years after the pile has been built. Prior to disposing of finished compost per NYSDOH regulations, fecal coliform counts of ≤ 200 MPN/gm, (NSF Standard 41 Non-Liquid Saturated Treatment Systems, Performance Criteria, 14.3) shall be met. Beginning in the spring of 2004, sampling of secondary compost and finished compost will be conducted in ac-

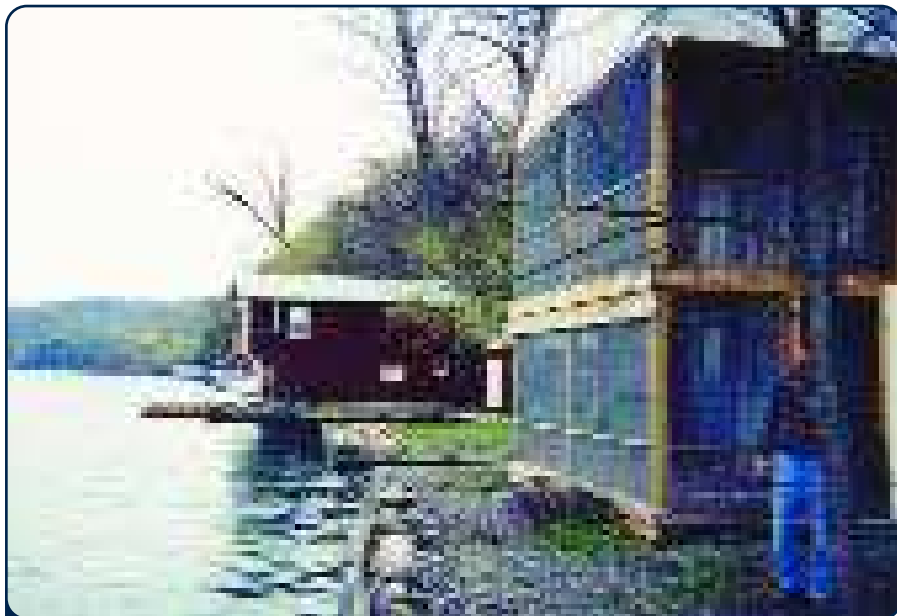
Some Skaneateles homes have been built partially extending out on the lake because of the limited land on the lakefront. Photo by Patricia Miller.
